HARDINGS

CHARTERED BUILDING SURVEYORS

BUILDING SURVEY REPORT

YOUR BUILDING SURVEY REPORT

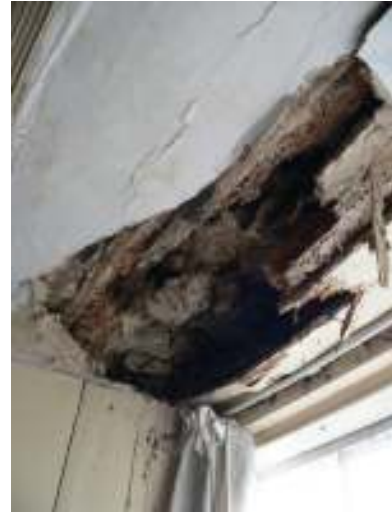
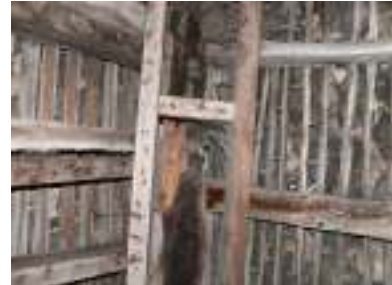
As to be expected in a property of this age there is exit holes consistent with common furniture beetle, death watch beetle and bark beetle. Bark beetle is a type of woodworm that affects recently felled timbers so we conclude that the exit holes from these have long since been dormant. Common furniture beetle and death watch beetle are active within the building primarily because there are timbers with excessive levels of moisture content which is ideal for this type of wood boring beetle. They do generally attack only the sapwood of the timbers as the hard wood does contain natural chemicals which are harmful to the wood boring beetle. However prolonged wetting of these timbers can allow the beetle to gain a hold. This is made worse where the wetting such as to the dining room area has allowed fungal growth to occur and in these areas the timbers will have to be replaced with new sound timber. The main point to remember is that the water ingress should be stopped and timbers allowed to dry out then they can be thoroughly assessed and where noticeably weakened, replaced.

Woodworm that is active was noticed within the visible roof timbers especially the ridge area, lintol and timbers above the dining room window. This is not to say that further activity will not be found once areas are opened up. It is also probable that you will find high quantities of dust from previous wood boring beetle activity that is now dormant. Dust should be removed and if you wish to determine whether there is continued infestation apply paper strips glued to the wood and then any emerging wood boring beetle will chew through the paper leaving a tell tale hole.

Replace weakened woodworm affected timbers.

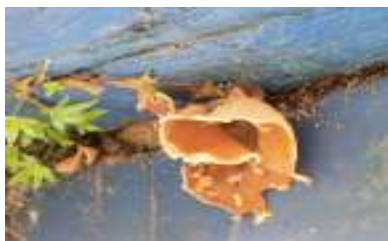
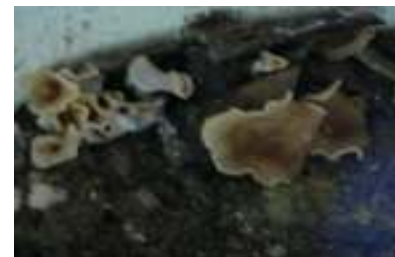
Because of the extensive water ingress there has been both wet and dry rot, the solution to resolving the problem is to stop the water ingress through the roofs, walls and high ground levels, allow the timber to dry out, determine its stability and if found to be weakened then replace with new sound wood. In places the wetting has been so great that fungus is growing on lintol heads and floors.

Replace all weakened and extensively decayed timbers.

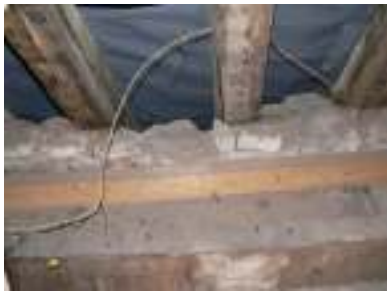
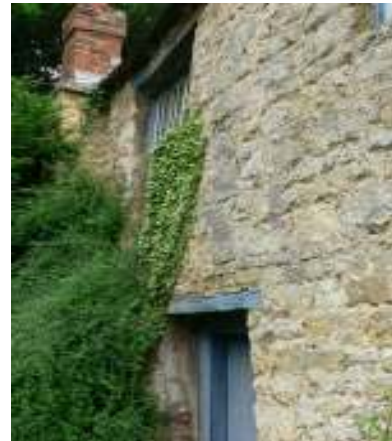
The reason why this roof covering will need to come off is because the roof rafters sit down upon the stone walls without the benefit of any ceiling joists being ties to the roof to restrain outward movement. This outward pressure has resulted in the walls moving, most noticeably on the South elevation of the West wing.

It is our opinion that this poor detail needs to be improved by way of restraining straps and framing tying into the floor, cross partitions and occasional cross tie beam. It can be achieved, it just requires careful thought and design.

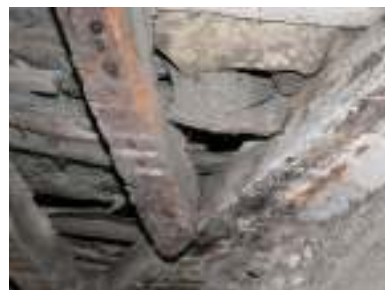
Some areas of the roof structure were visible such as those near the valley formed between the main house roof and the West wing, in this area noticeable movement has occurred causing the joints to open and fail, they will need to be reconstructed when the roof coverings are removed.

The pine ridge timber to the main house has suffered from extensive wetting resulting in extensive wood boring beetle activity that has caused it to fail and will need to be replaced.

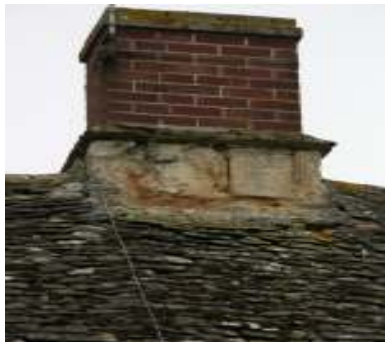
The chimney stack to the Northern end of the main house has weathered noticeably with significant loss of stone to the North and East side. It is recommended that the stone sections here be sympathetically repaired and where appropriate additional sections of stone installed.

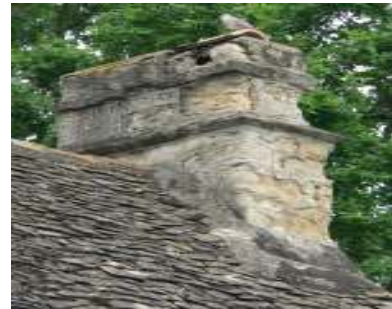
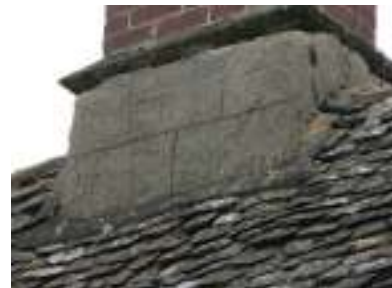
The chimney stack to the main house on the East end was of a similar stone structure that has now been lowered and re-built using bricks.

It is recommended that the brickwork be taken down and a new stone stack built. The rendered flashing detail on the West side of this stack should be removed and the stone sympathetically repaired with

appropriate flashing details.

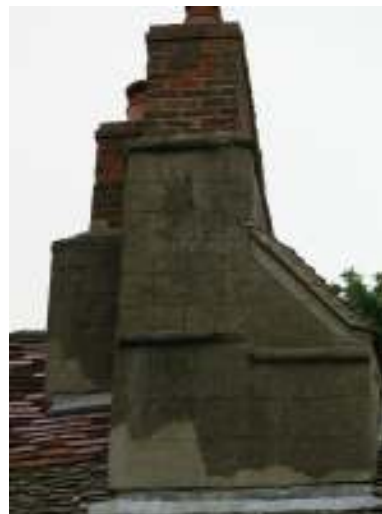
The large chimney stack complex to the West wing has been rendered on its lower sections, the render although recently patch repaired shows noticeable signs of sulphate attack therefore it is our recommendation that this render be removed in its entirety and once the brickwork is exposed determine whether it can be repaired and a new lime based render applied. The upper sections of brickwork are not that old and have been repointed using a cement based mortar which is inappropriate and while access is gained to this stack allow for removing the cement based repointing work, it may be more cost affective to simply re-build this stack in new brickwork within lime mortar.

Repair/re-build all but two chimney stacks.

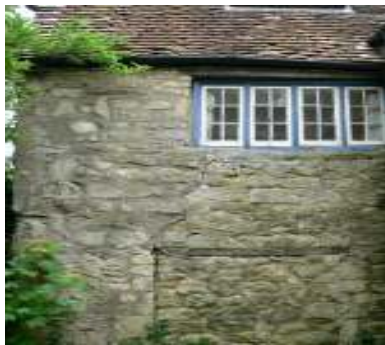
Inappropriate cement based repointing work, vertical butt joint crack where door opening once existed, decay of embedded timber lintel resulting in cracking from lintel up to cill of window above, outward spreading of roof structure between corner of building and window, green algae growth on wall due to defective rainwater goods now replaced.

Remove all previous cement based repairs, rake out all joints and repoint with a lime based mortar.

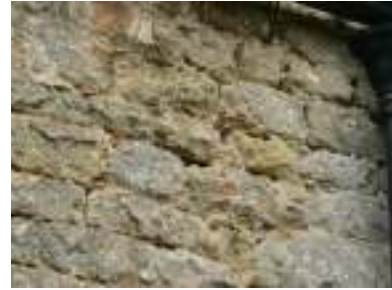
Sandstone within lime based mortar. Local repointing is in cement based mortar. Perished joints generally and extensive bulging and distortion of the elevation.

Rainwater is considered to have entered into the wall structure from the defective roof covering partly caused by the roof spread. This water ingress has caused the inner core to weaken allowing the weak roof structure to push the wall outwards, further increasing the deterioration of the roof covering and the joints to the walls allowing further water to permeate into the structure. This continued cycle will eventually result in the total collapse of this wall.

All previous cement based repairs need to be removed, the joints carefully raked out in small areas, small sections of stone to be removed to determine the condition of the core as it is anticipated the core will have deteriorated. In small areas, but eventually covering the whole wall, install a slurry lime based grout to stabilise the wall prior to repointing with lime based mortar. It is important that metal restraint ties are also installed from the wall back to the floor structures. Some initial repointing will be required to hold in the slurry.

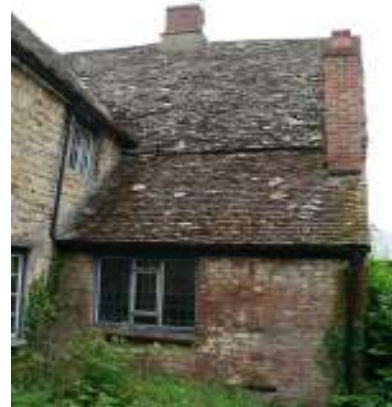
Original lime based mortar has perished and repointing in cement based mortar has accelerated the decay. Imbedded timber sections badly rotted away.

Joints where defective rainwater goods exist have been completely washed out.

Remove all previous cement based repairs and rotten timber sections, replacing the timber sections with brickwork and then repoint in lime based mortar.

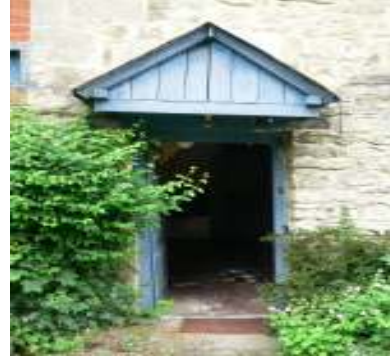
South gable to main house.

Distortion of entrance area occurred some time ago and partial re-building and repointing was undertaken using cement based products. The settlement is long established and as far as we can determine stabilised. It would be of benefit to remove the cement based repointing work and renew with lime based mortar but we suspect the upper sections to have been completely re-built however further tests could be undertaken to determine whether it is simply surface pointing. If it is then it can be repoint using lime based mortar.

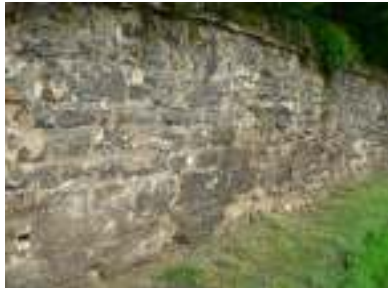
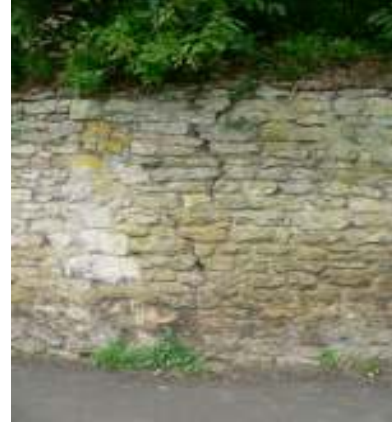
Sandstone walls are suffering from forces exerted by trees growing close to the walls and the joints are badly perished in large areas. Quite extensive repairs are required to the

external walls by way of repointing and replacing badly perished sections of stone especially where cement based work has been undertaken in the past.

It would also be prudent to remove the trees that are causing the damage to the walls currently.

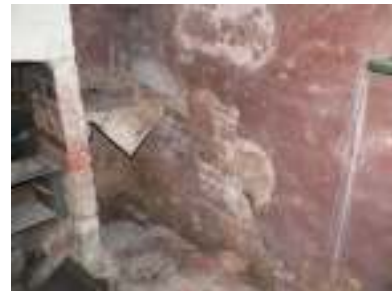
Extensive water penetration both horizontally and from above vertically with significant deterioration of internal plaster finishes, cracking and distortion to the masonry walls partly as a result of the heat generated from the oven and also deterioration of the external wall which has resulted in movement at an earlier time.

All water ingress needs to be abated, damaged and defective plaster removed, external pointing, etc. attended to, allow the wall to dry out and then re-plastering can be considered.

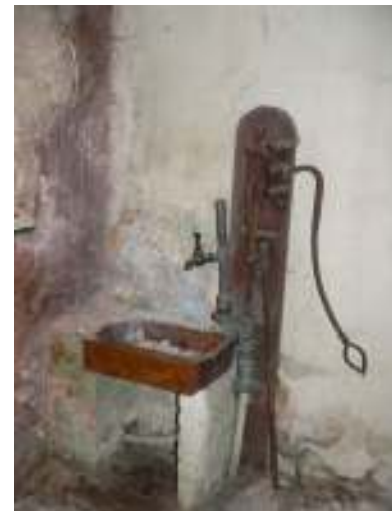
Traditional oven has deteriorated over time with some of the cast iron sections being broken but could possibly still be used as a feature as could the hand pump.

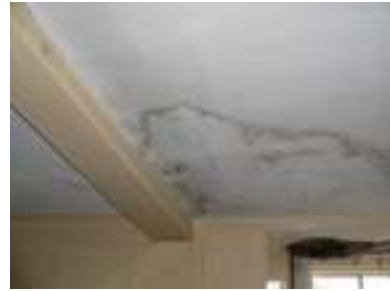
Original lath and plaster ceiling with cracking grinning through the various paint and paper finishes. Extensive wet staining from the bathroom above, this has resulted in fungal decay of the principal lintol over one of the windows. The wet timbers have also been attacked by both common furniture and death watch beetle.

Damaged ceiling will need to be taken down, all timbers examined and those affected by the water which have now been weakened will need to be replaced as will the lintol above window. It will also be necessary to re-build some of the masonry wall above the window as this has now moved downwards as a result of the lintol failure.

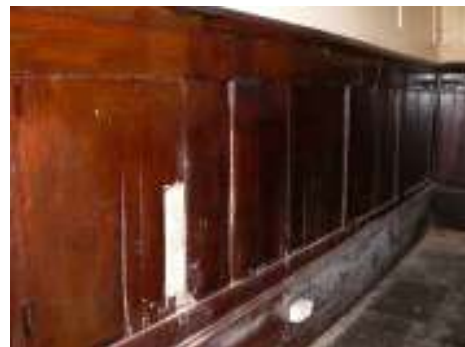
Timber panelling below dado rail has suffered from fungal decay due to water ingress through the masonry structure, there has also been extensive condensation causing a white mould to occur on the surface of the panelling. Moisture meter indicates there are above average moisture levels within the timber and there is a distinct possibility that the fixings securing these panelled walls will have decayed over time due to condensation and water ingress. This will only really become apparent once the damaged panels are removed for replacement and the fixings become exposed. In order to determine the full extent of the decay it will be necessary to open up sections of panelling either before purchase which is the ideal solution or accept the risk that works will be necessary in this area once purchase completed.

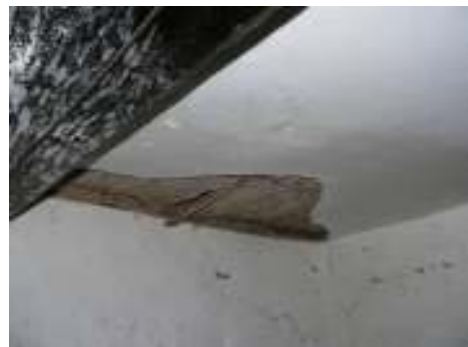
Lath and plaster ceiling with slight cracking consistent with age. Section of ceiling has collapsed and needs to be attended to. The exposed timber beam is saturated and water ingress needs to be stopped before noticeable decay occurs. It is of concern that the beam end may well be extensively rotten and this needs to be opened up and repairs allowed for.

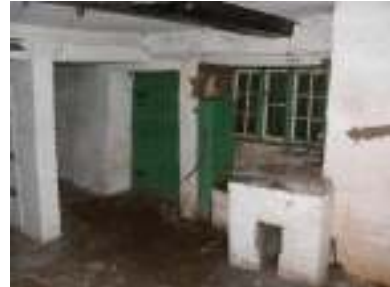
Uneven brick on earth floor with well worn sections in trafficated zone near to the traditional brick copper.

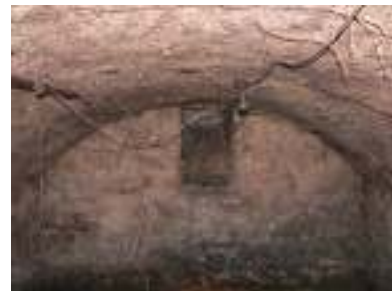
12.08 CELLAR

- Brick and stone cellar built underneath the garden on the North side of the store with well worn treads leading down into the cellar, there is also a sump that at the time of our inspection held water and it is recommended that this sump be investigated further to see whether the drain does discharge to a drain system or simply forms a catchment sump for water to be pumped out in which case if it is the latter a pump needs to be provided.

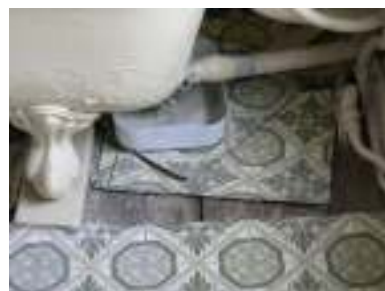
Mix of old and more recent pine floorboards. The old sections show signs of woodworm and decay

due to leaking bath, these sections will need to be repaired.

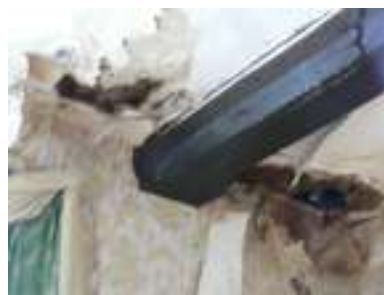
Heavily distorted ceiling with lath and plaster following the distortions due to previous movement also decay of ceilings especially where water ingress has occurred resulting in fungal growth on walls and floor. Where tie beam enters wall and associated roof timbers, decay is extensive and it should be expected that the tie beam end and adjacent timbers will have to be replaced.

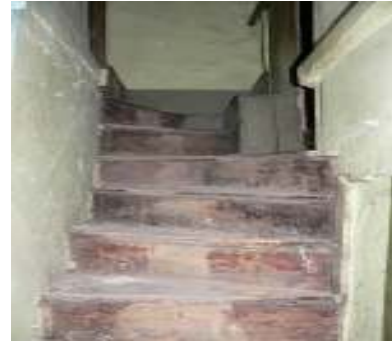
Stairs of even rise and going accepting the winders, majority of treads have decayed due to wood boring beetle activity and need to be replaced.

Repair stair treads.

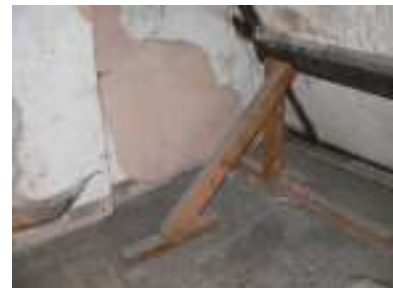
Original timber purlin has at some stage either rotted or been cut away and timber bracing put in, recommend a replacement purlin is installed with appropriate joint system. Where an original bracing timber to a high level purlin is built into the North end wall we suspect this is rotting badly and will need to be cut out and replaced with a new one.

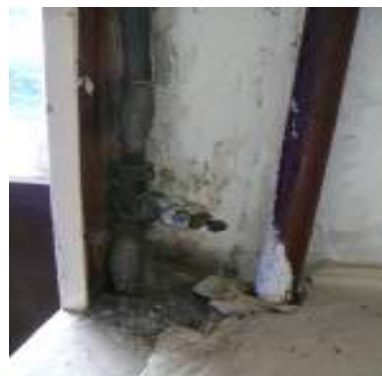
Incoming mains by way of lead pipe located in cupboard in corner of dining room. The majority of pipework where viewed was old lead pipe which is a health hazard therefore recommend the entire cold water plumbing water system be replaced with new modern copper or plastic system.

Install complete new cold water plumbing system.
