HARDINGS

CHARTERED BUILDING SURVEYORS

BUILDING SURVEY REPORT

YOUR BUILDING SURVEY REPORT

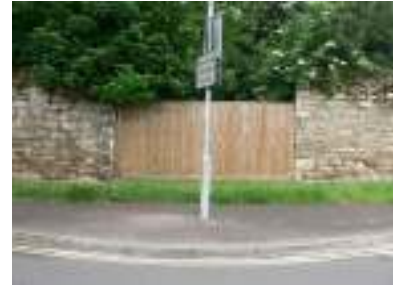
11.03 ACCESS

Pedestrian access only to the site with a personal gate entry on the North boundary West end and one within the East boundary wall. Evidence to suggest there was vehicle entry point a little bit further along the Eastern wall boundary now not possible due to the changes in pavement and road furniture.
